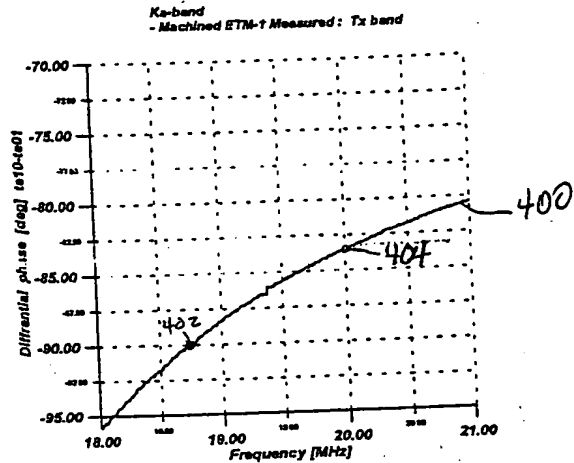
Fig. 4a

ETM-1 Measured Tx band (as built)

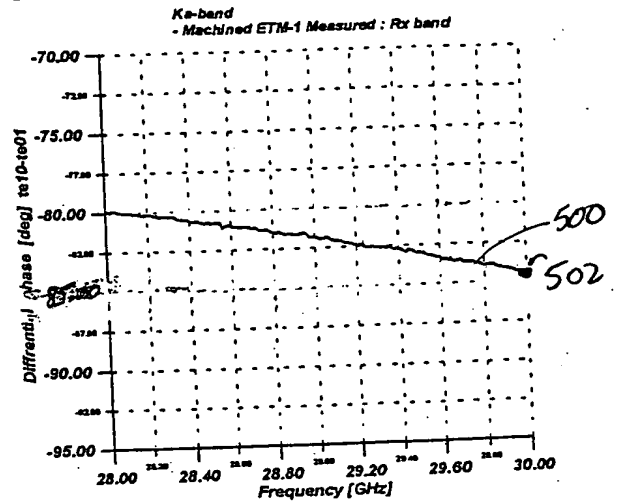
Fig. 5a

ETM-1 Measured RX Band(as built)

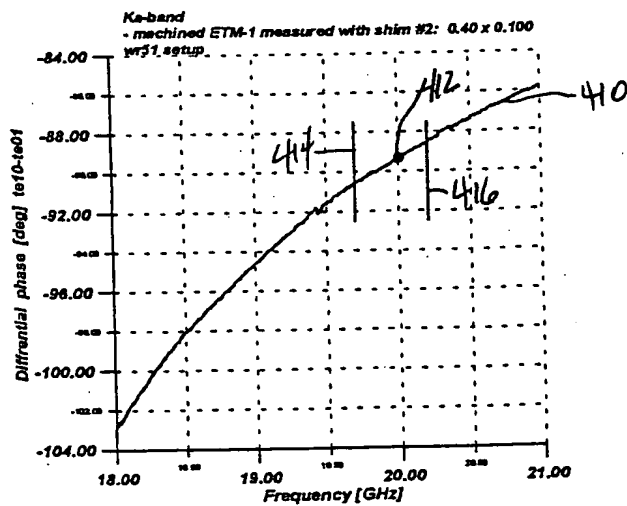
Fig. 4b

ETM-1 Measured with Phase trimming
Tx band

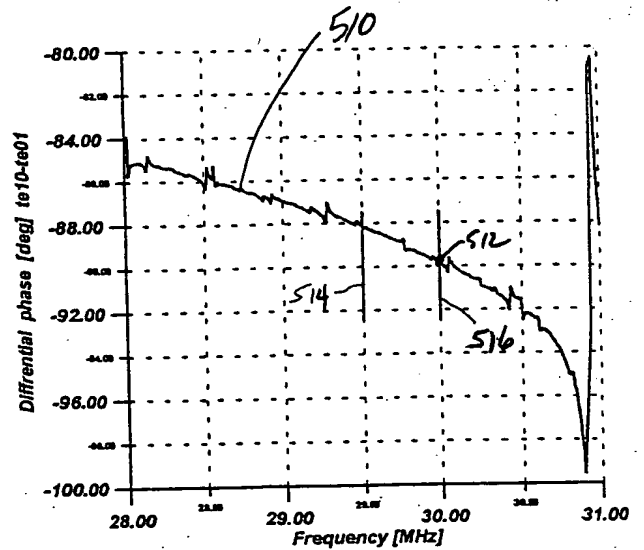
Fig. 5b

ETM-1 Measured with Phase trimming
Rx band

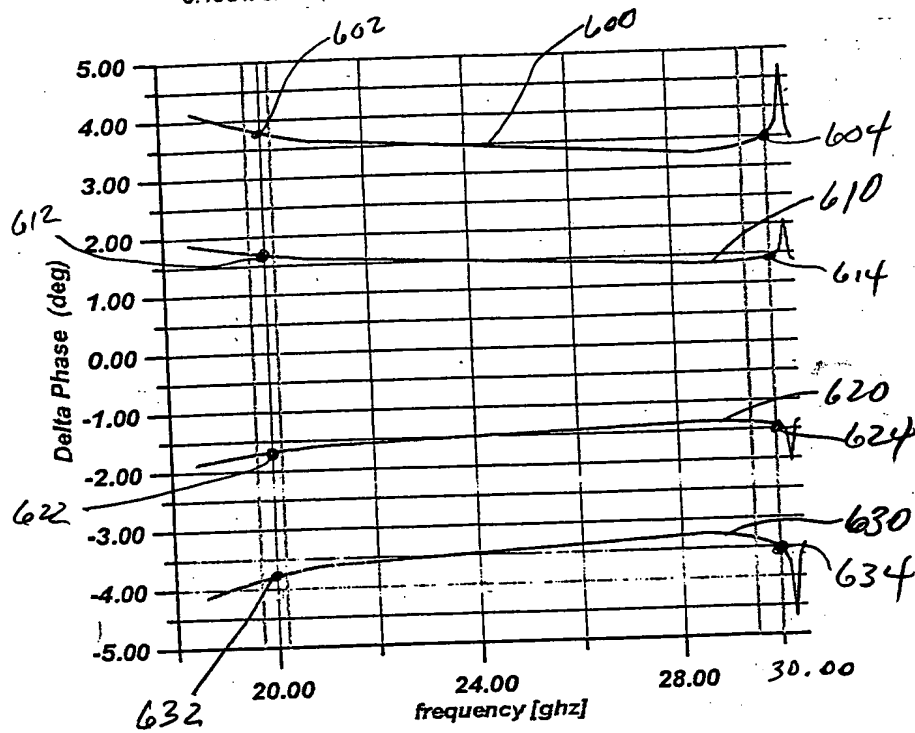
Fig. 6

Predicted differential phase shift Vs
device dimensions - 2 Cases

Ka-band Corrugated Polarizer delta phase trimmer
0.400 x 0.4355 x .05 / 0.415 x 0.4355 x .050
